FBPE
FLORIDA BOARD OF
PROFESSIONAL ENGINEERS

Jacksonville Parking Garage Collapse - 5 YEAR REVIEW

by: William C. Bracken, P.E., S.I., CFM

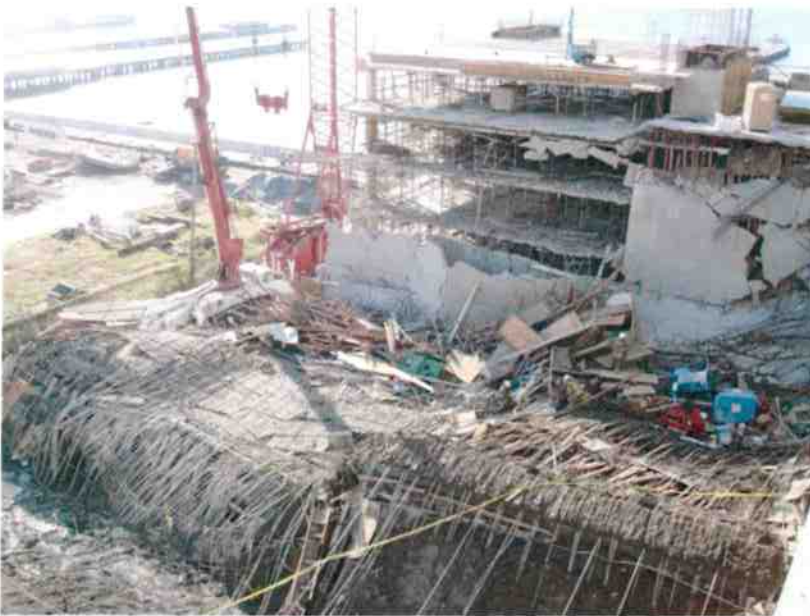
December 6th 2007, the 6-story parking garage that was under construction across the street from the police station in downtown Jacksonville, Florida collapsed suddenly and without warning. The collapse resulted in the death of one worker and the injury of 20 more. The following review is based on the investigations conducted by and the documents obtained from the Occupational Safety and Health Administration (OSHA) and the Florida Board of Professional Engineers (FBPE).

The structure that collapsed was a 6-story parking garage. The parking garage was being constructed utilizing cast-in-place simple reinforced concrete columns, cast-in-place reinforced and post-tensioned concrete beams, and cast-in-place post-tensioned concrete slabs. The parking garage sat atop its own foundations and was structurally independent from the 23 story high-rise it was to service.

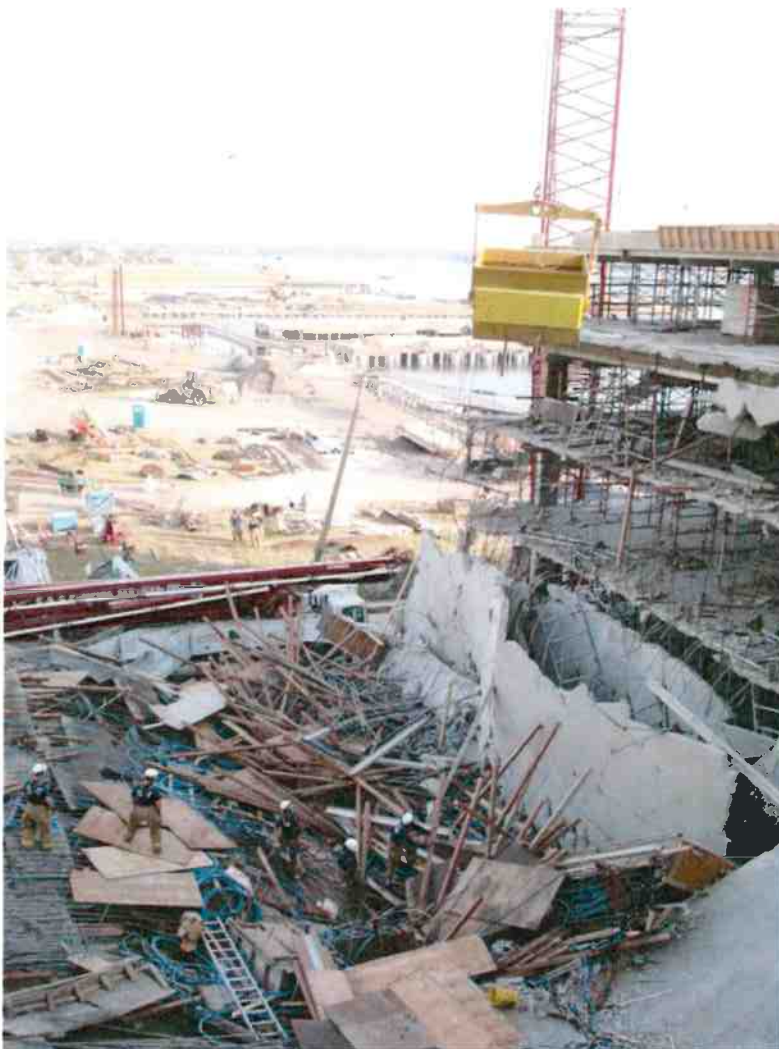
The structural design drawings were signed and sealed by the engineer of record (**Soheil Rouhi**). OSHA reported that, while the construction of the parking garage included many minor and major issues, “the difficulties were compounded by the fact that the SER [structural engineer of record] was not forthcoming in resolving the questions, and had a nonchalant and dispassionate attitude towards the structure he designed.” OSHA also stated that the “SER denied this during an interview with OSHA.” In addition, it was learned that reinforcing steel had been left out and/or misplaced during the construction.

- > From the flexural aspect, the beam design was deficient under code prescribed load and phi factors.
- > The shear stirrups were significantly under-designed for the factored dead and live loads and did not meet the code requirements.
- > Of the eight columns, all except H4 were determined to be deficient as per the prescribed codes, based upon the 5,000 psi concrete, the strength specified by the SER.
- > The column C4 was considered the most critical. For load case No.1, C4 was barely able to support the dead loads even when the phi factor was not considered. This is the most serious design flaw in the structure.
